SPN1 -50°C Test Report

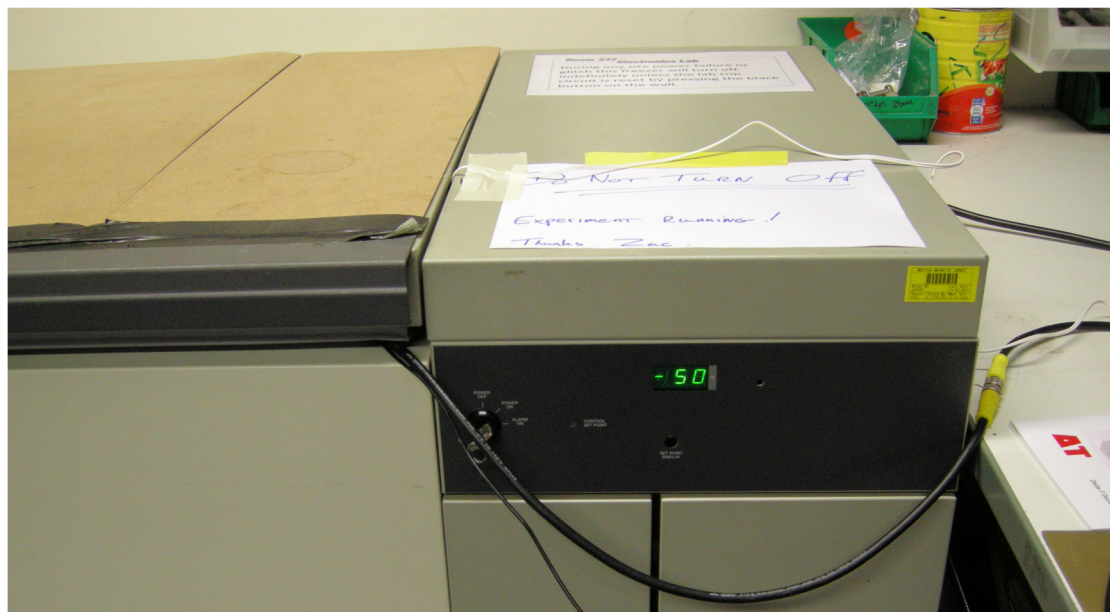
Figure 4 BAS Freezer at -50C showing the inline M12 connector in the SPN1 analogue cable. This connection was disconnected for 3 days to simulate 3 days without power at McMurdo

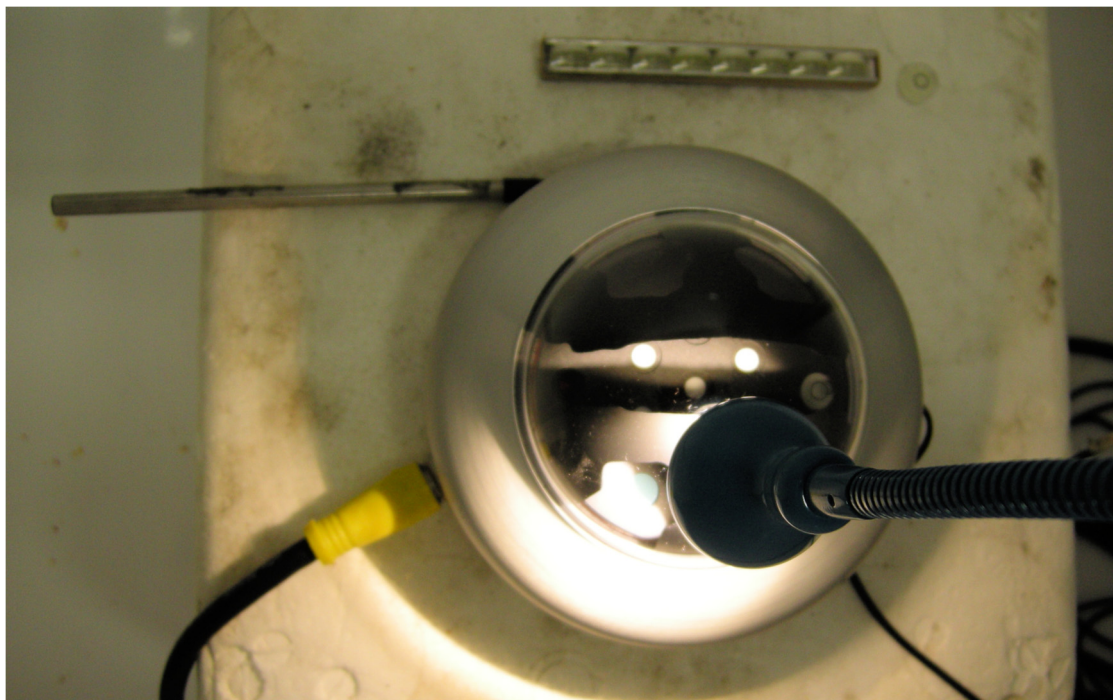
On Monday 16/3/2015 10:00 the top loading freezer was opened and a photo taken of the SPN1 and bubble levels, showing no damage (see photos).

Figure 8: SPN1 in freezer at -50C, still logging after 6 days at -50C, of which 3 were without any power. The picture also shows 10 bubble levels and a Delta-T type ST4 thermistor temperature sensor. The light was applied temporarily to check the SPN1 was still working.

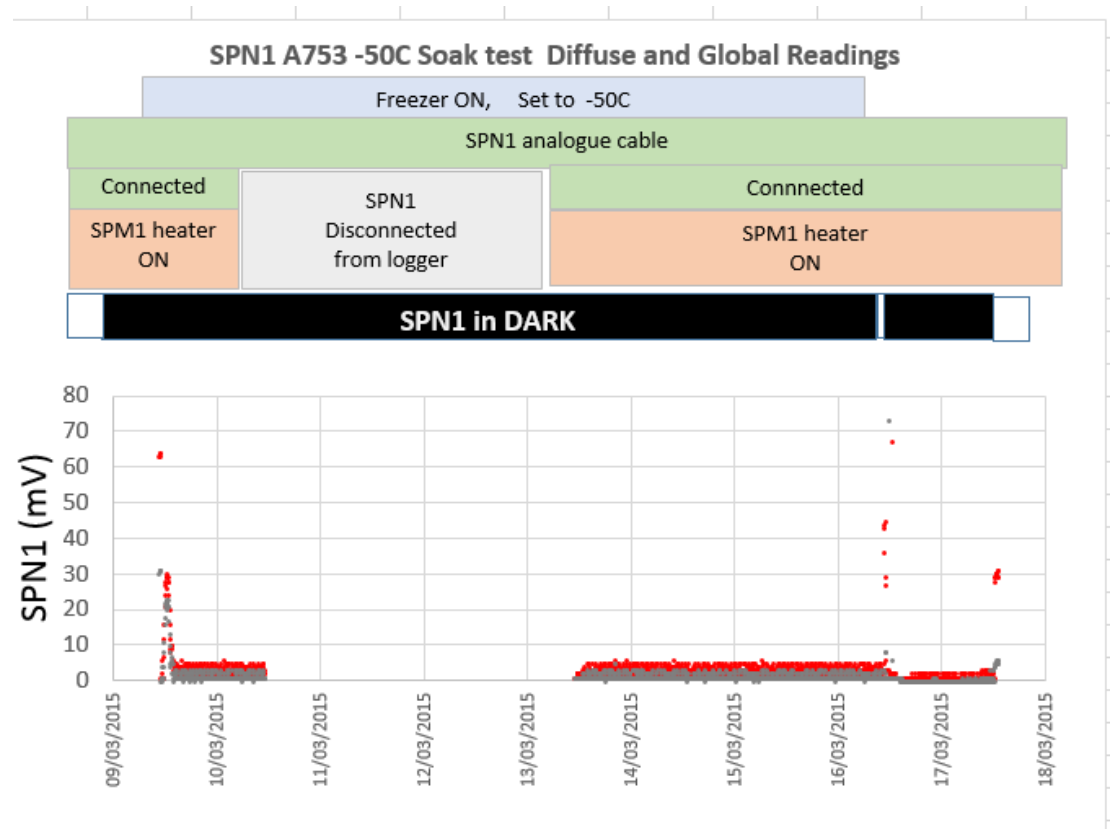
Figure 9 SPN1 Global and Diffuse readings logged as mV over 8 days

During the rapid cool down to -50°C both Global and Diffuse showed positive offset errors up to 30mV.

On warmup from -50 to 20°C (without the SPN1 heater on) the offset moved in the other direction, reducing to 1.3 and 0.09 mV respectively. This behaviour is what one would expect from a normally functioning SPN1.

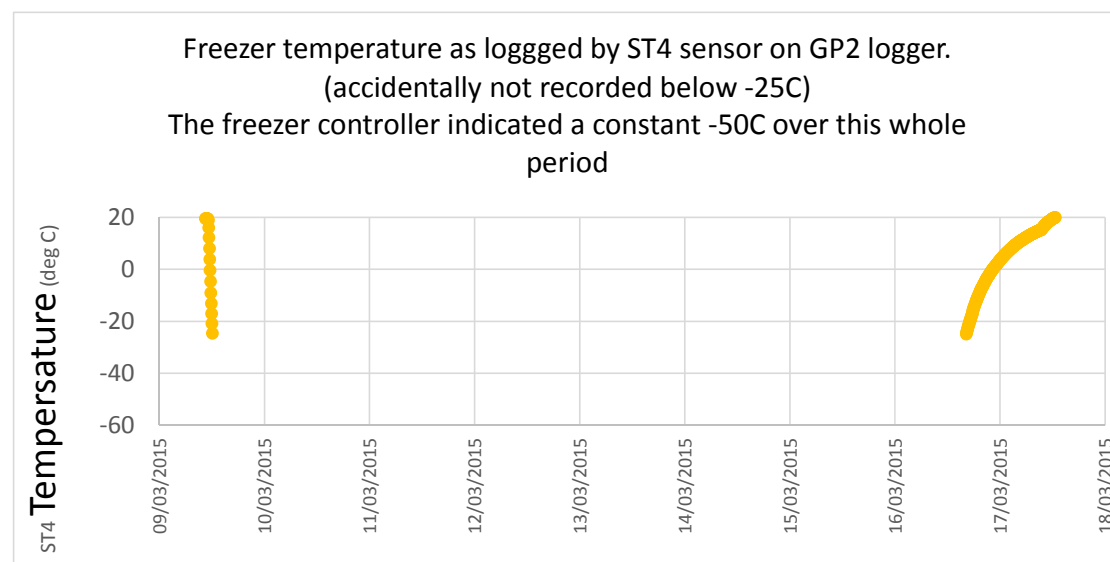
(Note I had programmed this sensor with a lookup table to read down to minus 50C - but had not tested this. In the event the logger rejected all readings below -25°C, logging those readings as faulty, and recording NAN# for "Not A Number". This had no impact on the freezer, which happily achieved -50C in under a day and sat there happily for the whole week as indicated by its independent controller.)

Figure 10 ST4 thermistor sensor readings in freezer. Data accidentally clipped below -25 C

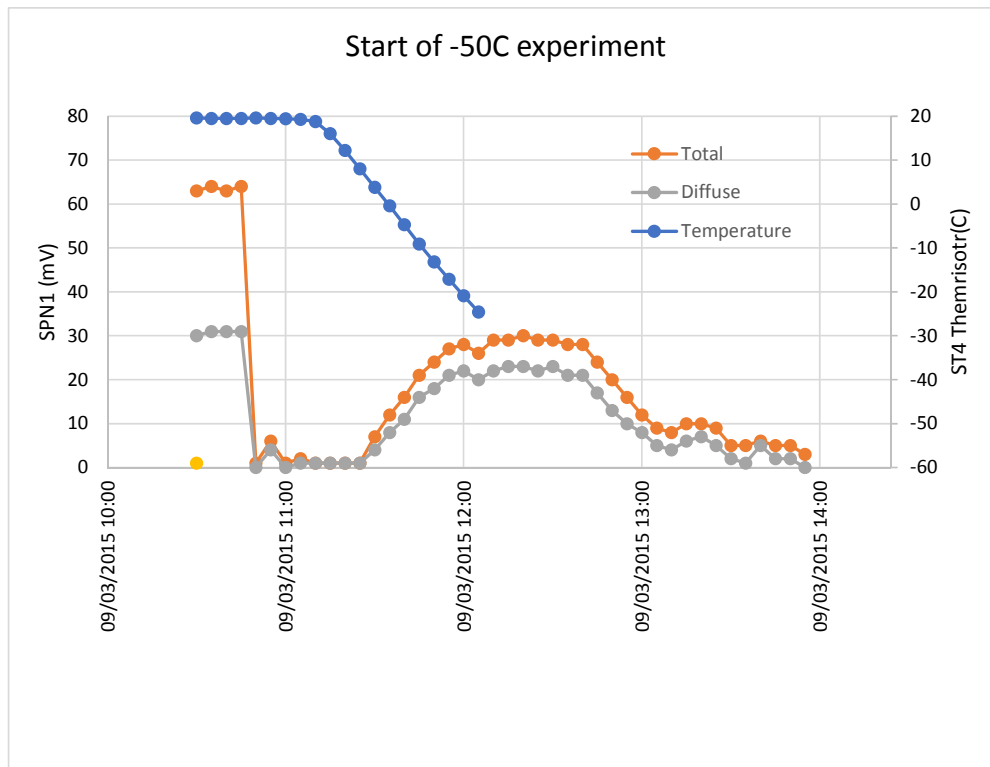
Figure 11 Logged data at the start. Steady Global and Diffuse readings under the desk light on the bench. SPN1 then into the freezer in the dark. During the rapid cool-down the SPN1 sensors show a tempco offset error. The oven was observed to reach -50C by about 2pm. After this the Global and Diffuse readings stabilised at $3 (\pm 1)$ and $1.4 (\pm 0.7)$ mV.

Once stable at -50°C the average logged SPN1 Global and Diffuse readings were 3.0 (± 1) and 1.4(± 0.7) mV. These positive offsets are normal for SPN1s in the dark.

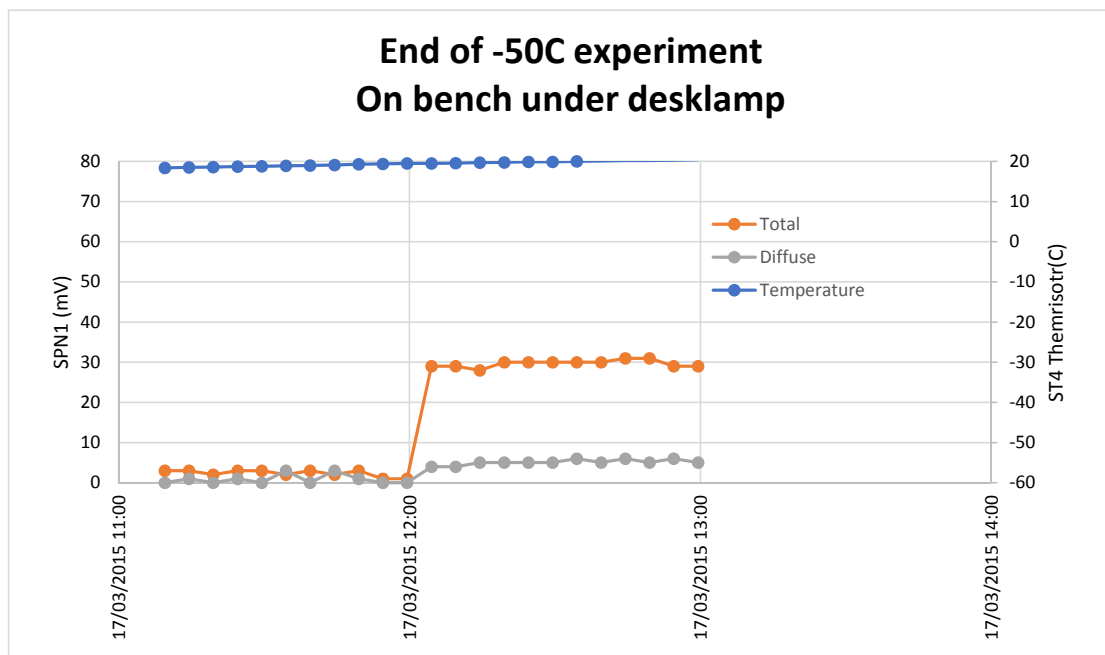
Figure 12 SPN1 data at end of experiment on bench under lamp. The measured Global and Diffuse readings have returned to the pre-test values.

Finally, back at ambient 20°C under a lamp both analogue and serial reading tracked each other.
