SPN1 -50°C Test Report

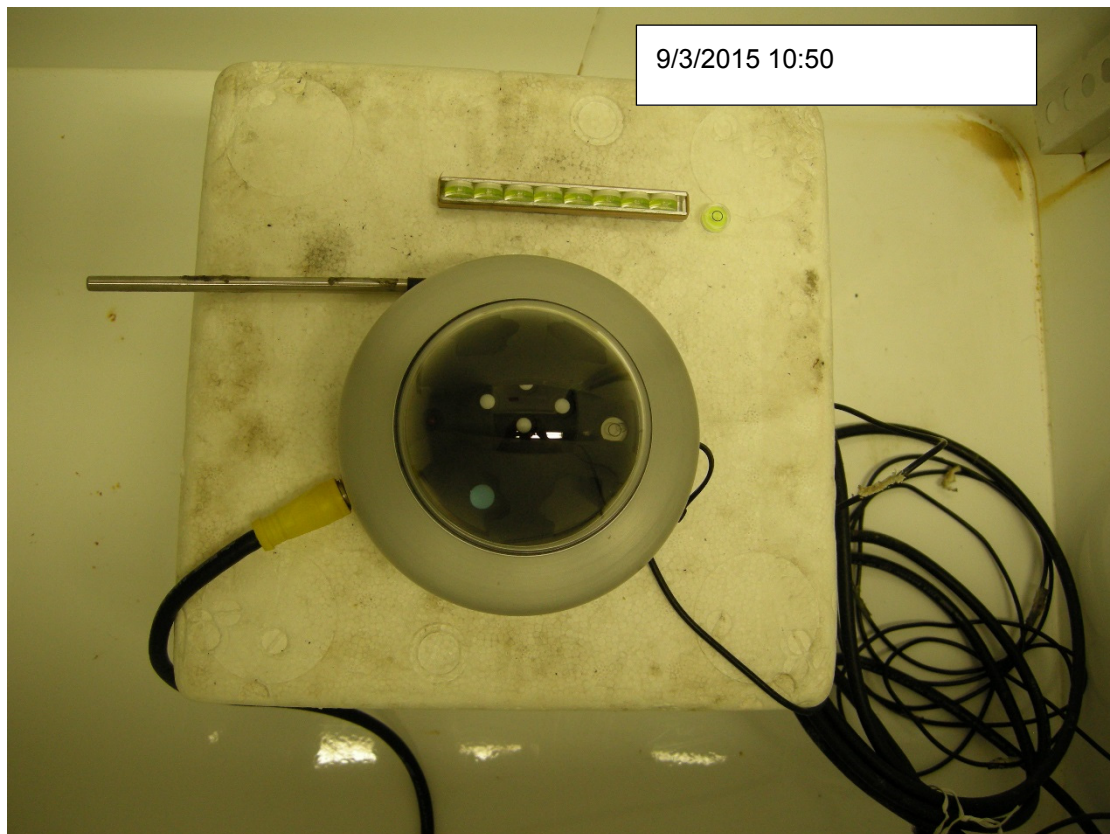
Figure 3 In freezer with bubble levels at 10:50 on 9/3/2015 before freezer is turned on.

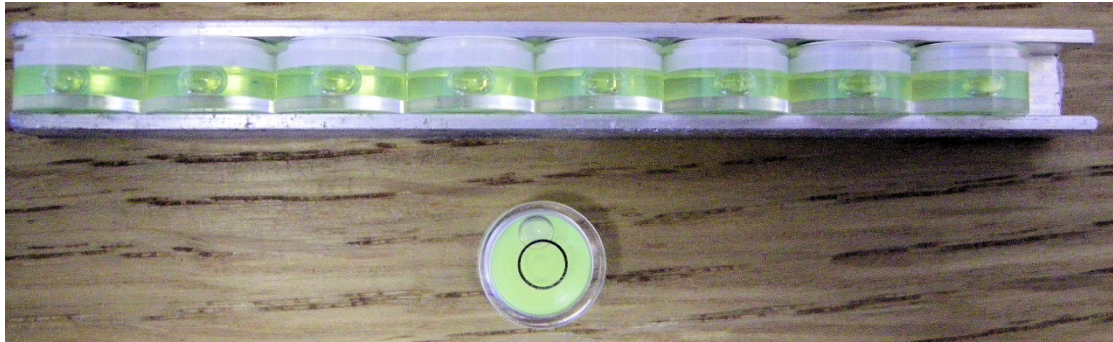
Ten alcohol filled bubble-levels of the sort used in the SPN1 also survived with no apparent damage.

Figure 5 Bubble levels before -50C test
